Model 1061 SEM Mill

Solder bump joint sample preparation for failure analyses

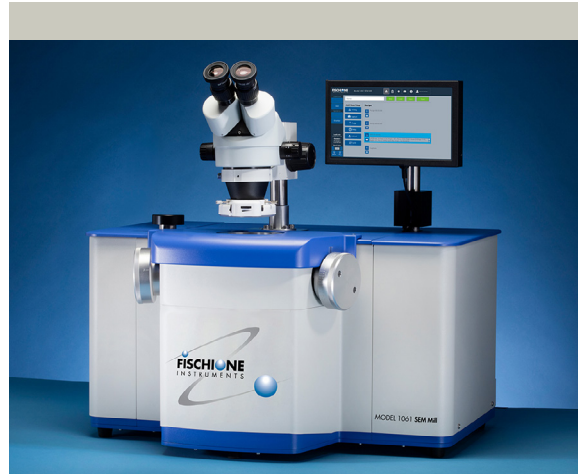
Figure 2. Model 1061 SEM Mill.

The BIB milling technique was also used to prepare a solder bump sample. The BIB milling technique consists of material removal (polishing) by accelerated argon ions. We present here the capabilities of Fischione Instruments Model 1061 SEM Mill (Figure 2). The ion milling conditions described in Table 2 are the milling parameters used to prepare the solder bump sample. Because tin solder bumps are thermal sensitive, liquid nitrogen was used to cool the ion mill's sample stage to -150 °C during milling.

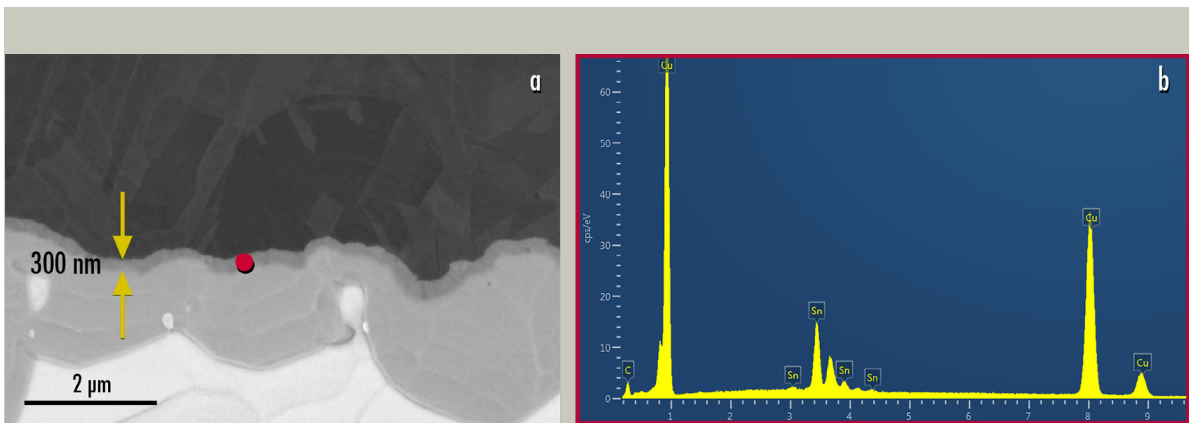
Figure 8. High-magnification scanning electron microscopy image of a copper pad/solder joint interface (a); energy-dispersive X-ray spectroscopy analysis identified a nanostructural intermetallic phase identified as Cu₃Sn (b).

EDS analyses, combined with EBSD technique, allowed identification of all of the phases shown in Figure 7. High-magnification observation of the copper/solder interface revealed a fifth phase, Cu_3Sn , as shown in Figure 8. The high quality EBSD patterns used for phase determination were possible because of the outstanding surface preparation after ion milling.
